9.0 CITY OF EDEN PRAIRIE

9.4 Eden Prairie Gully Progression

9.5 Eden Prairie High-Priority Regions

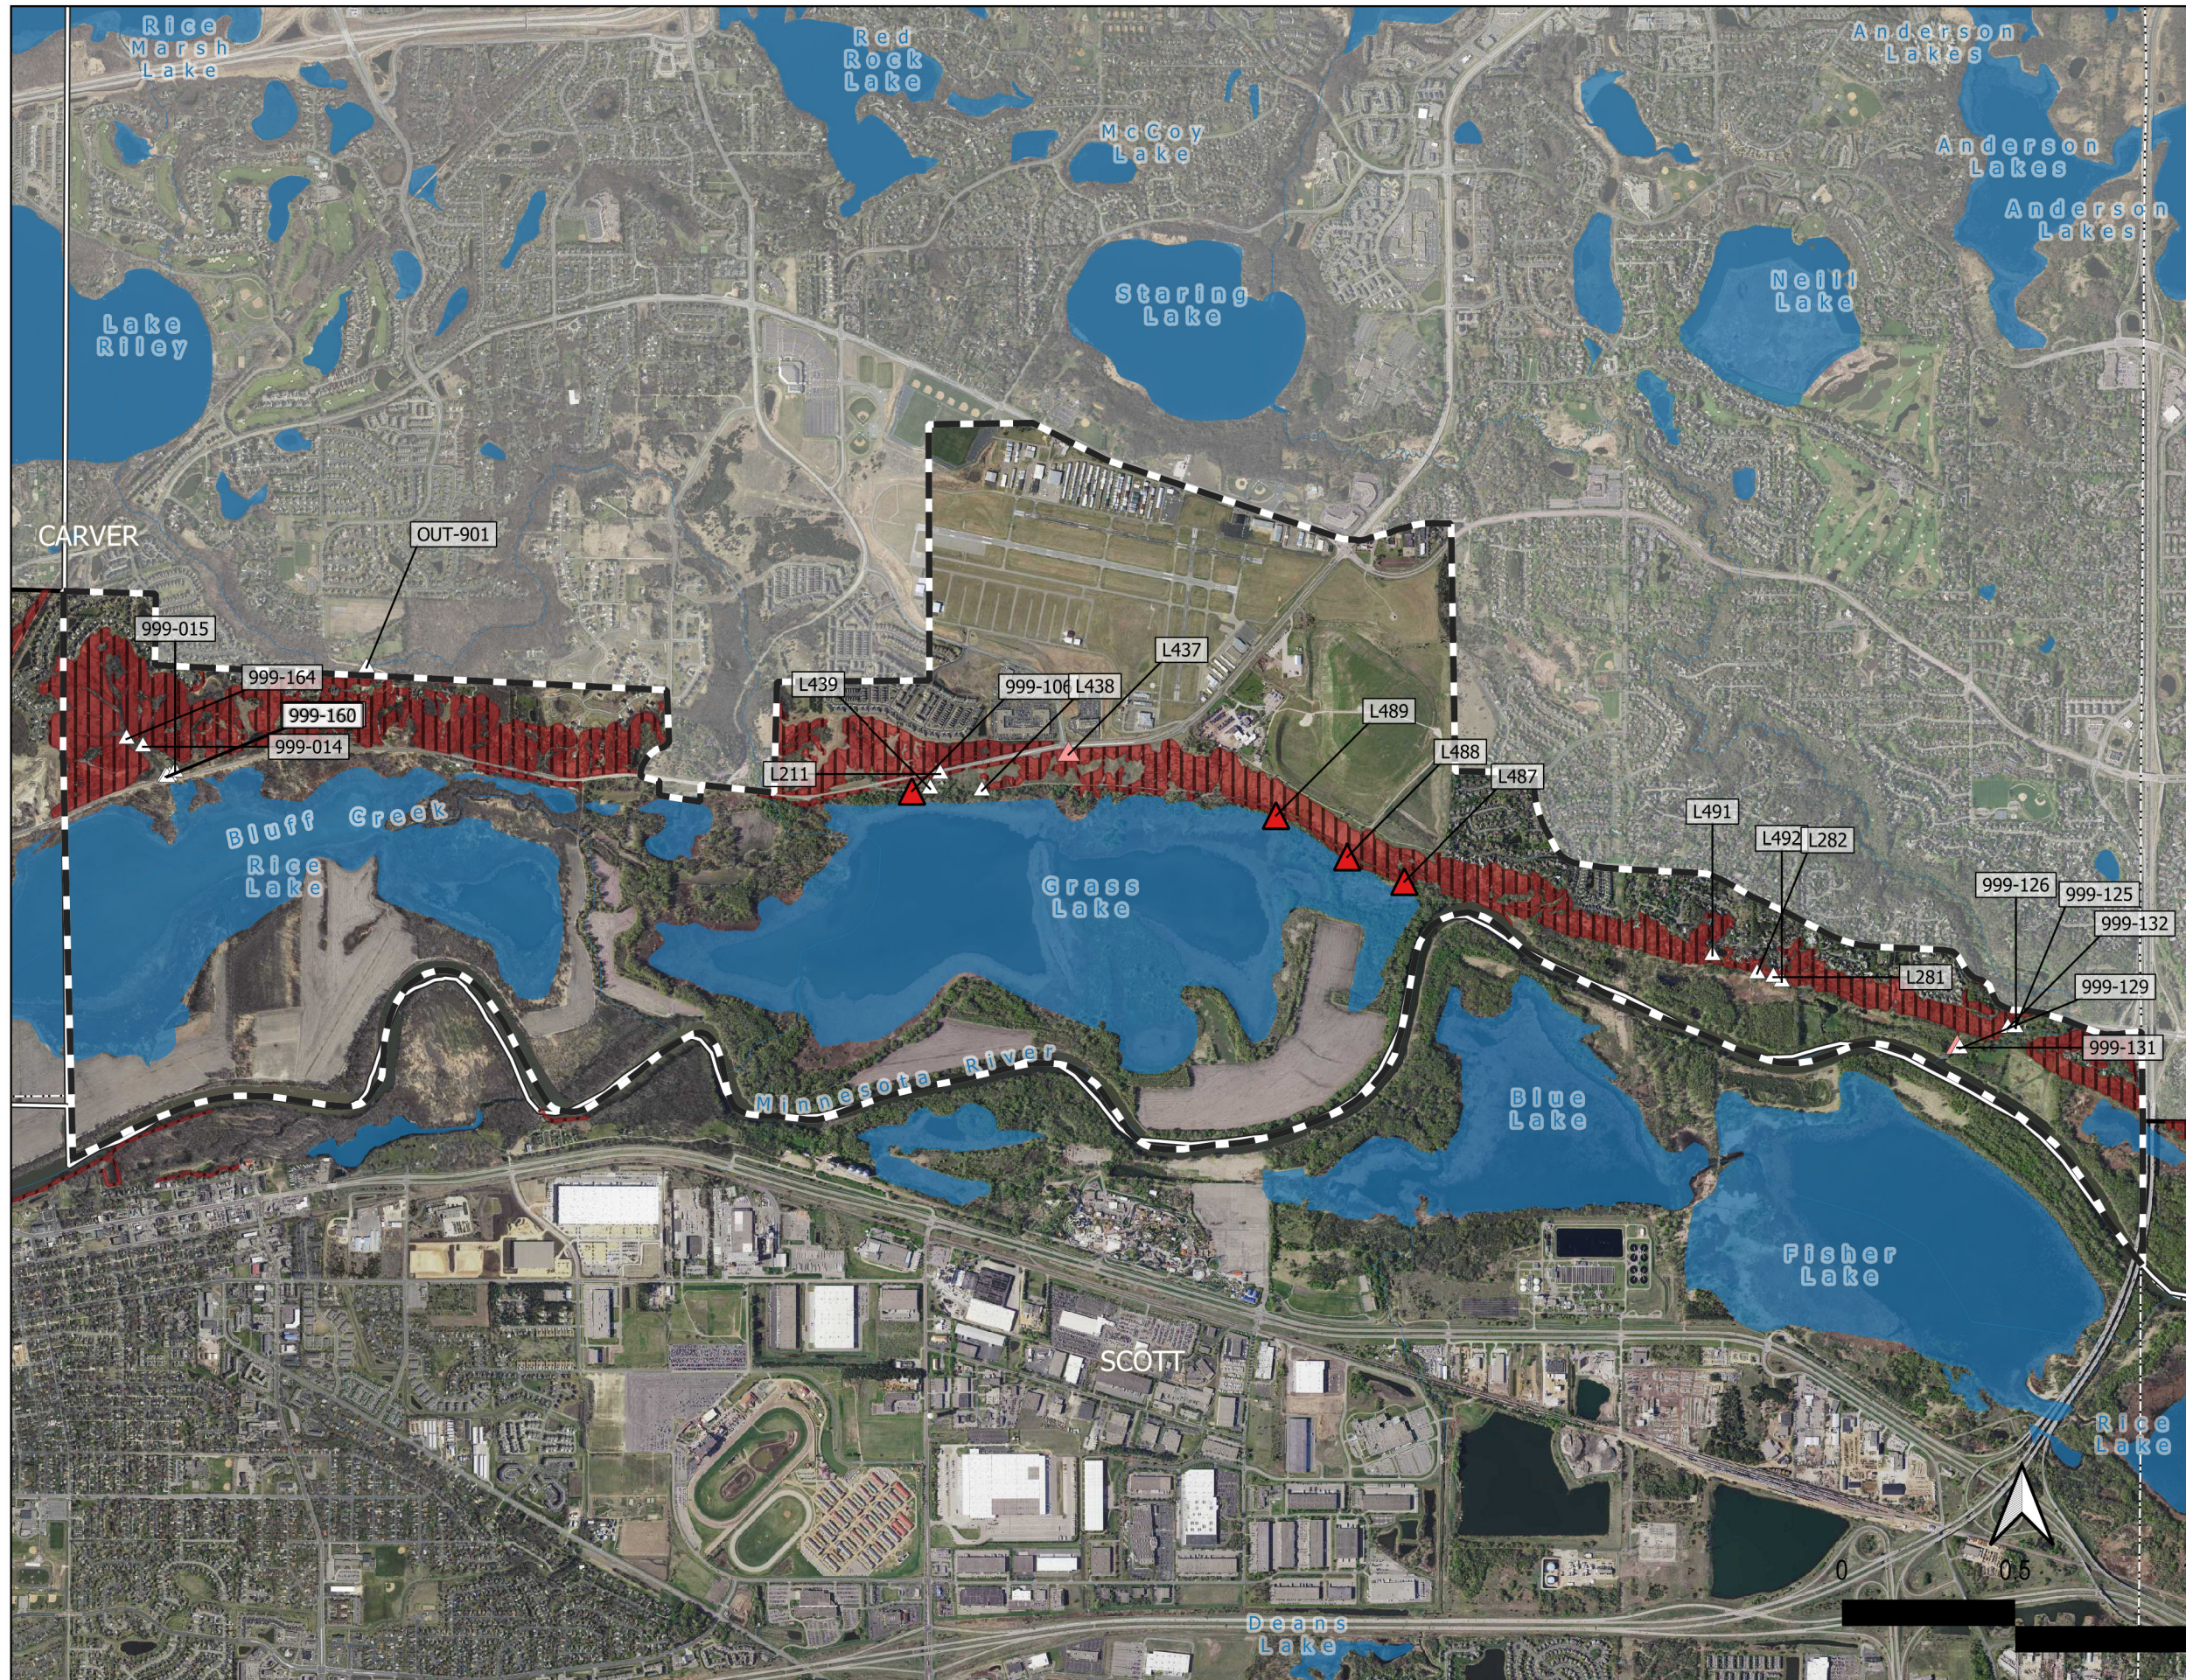
**Figure 92:
Eden Prairie 2020
Pipe Outfall
Conditions**

The field team noted four pipe outfalls in need of repair in Eden Prairie (**Figure 92**) and assessed the current gully conditions in terms of erosion potential (**Figure 93**).

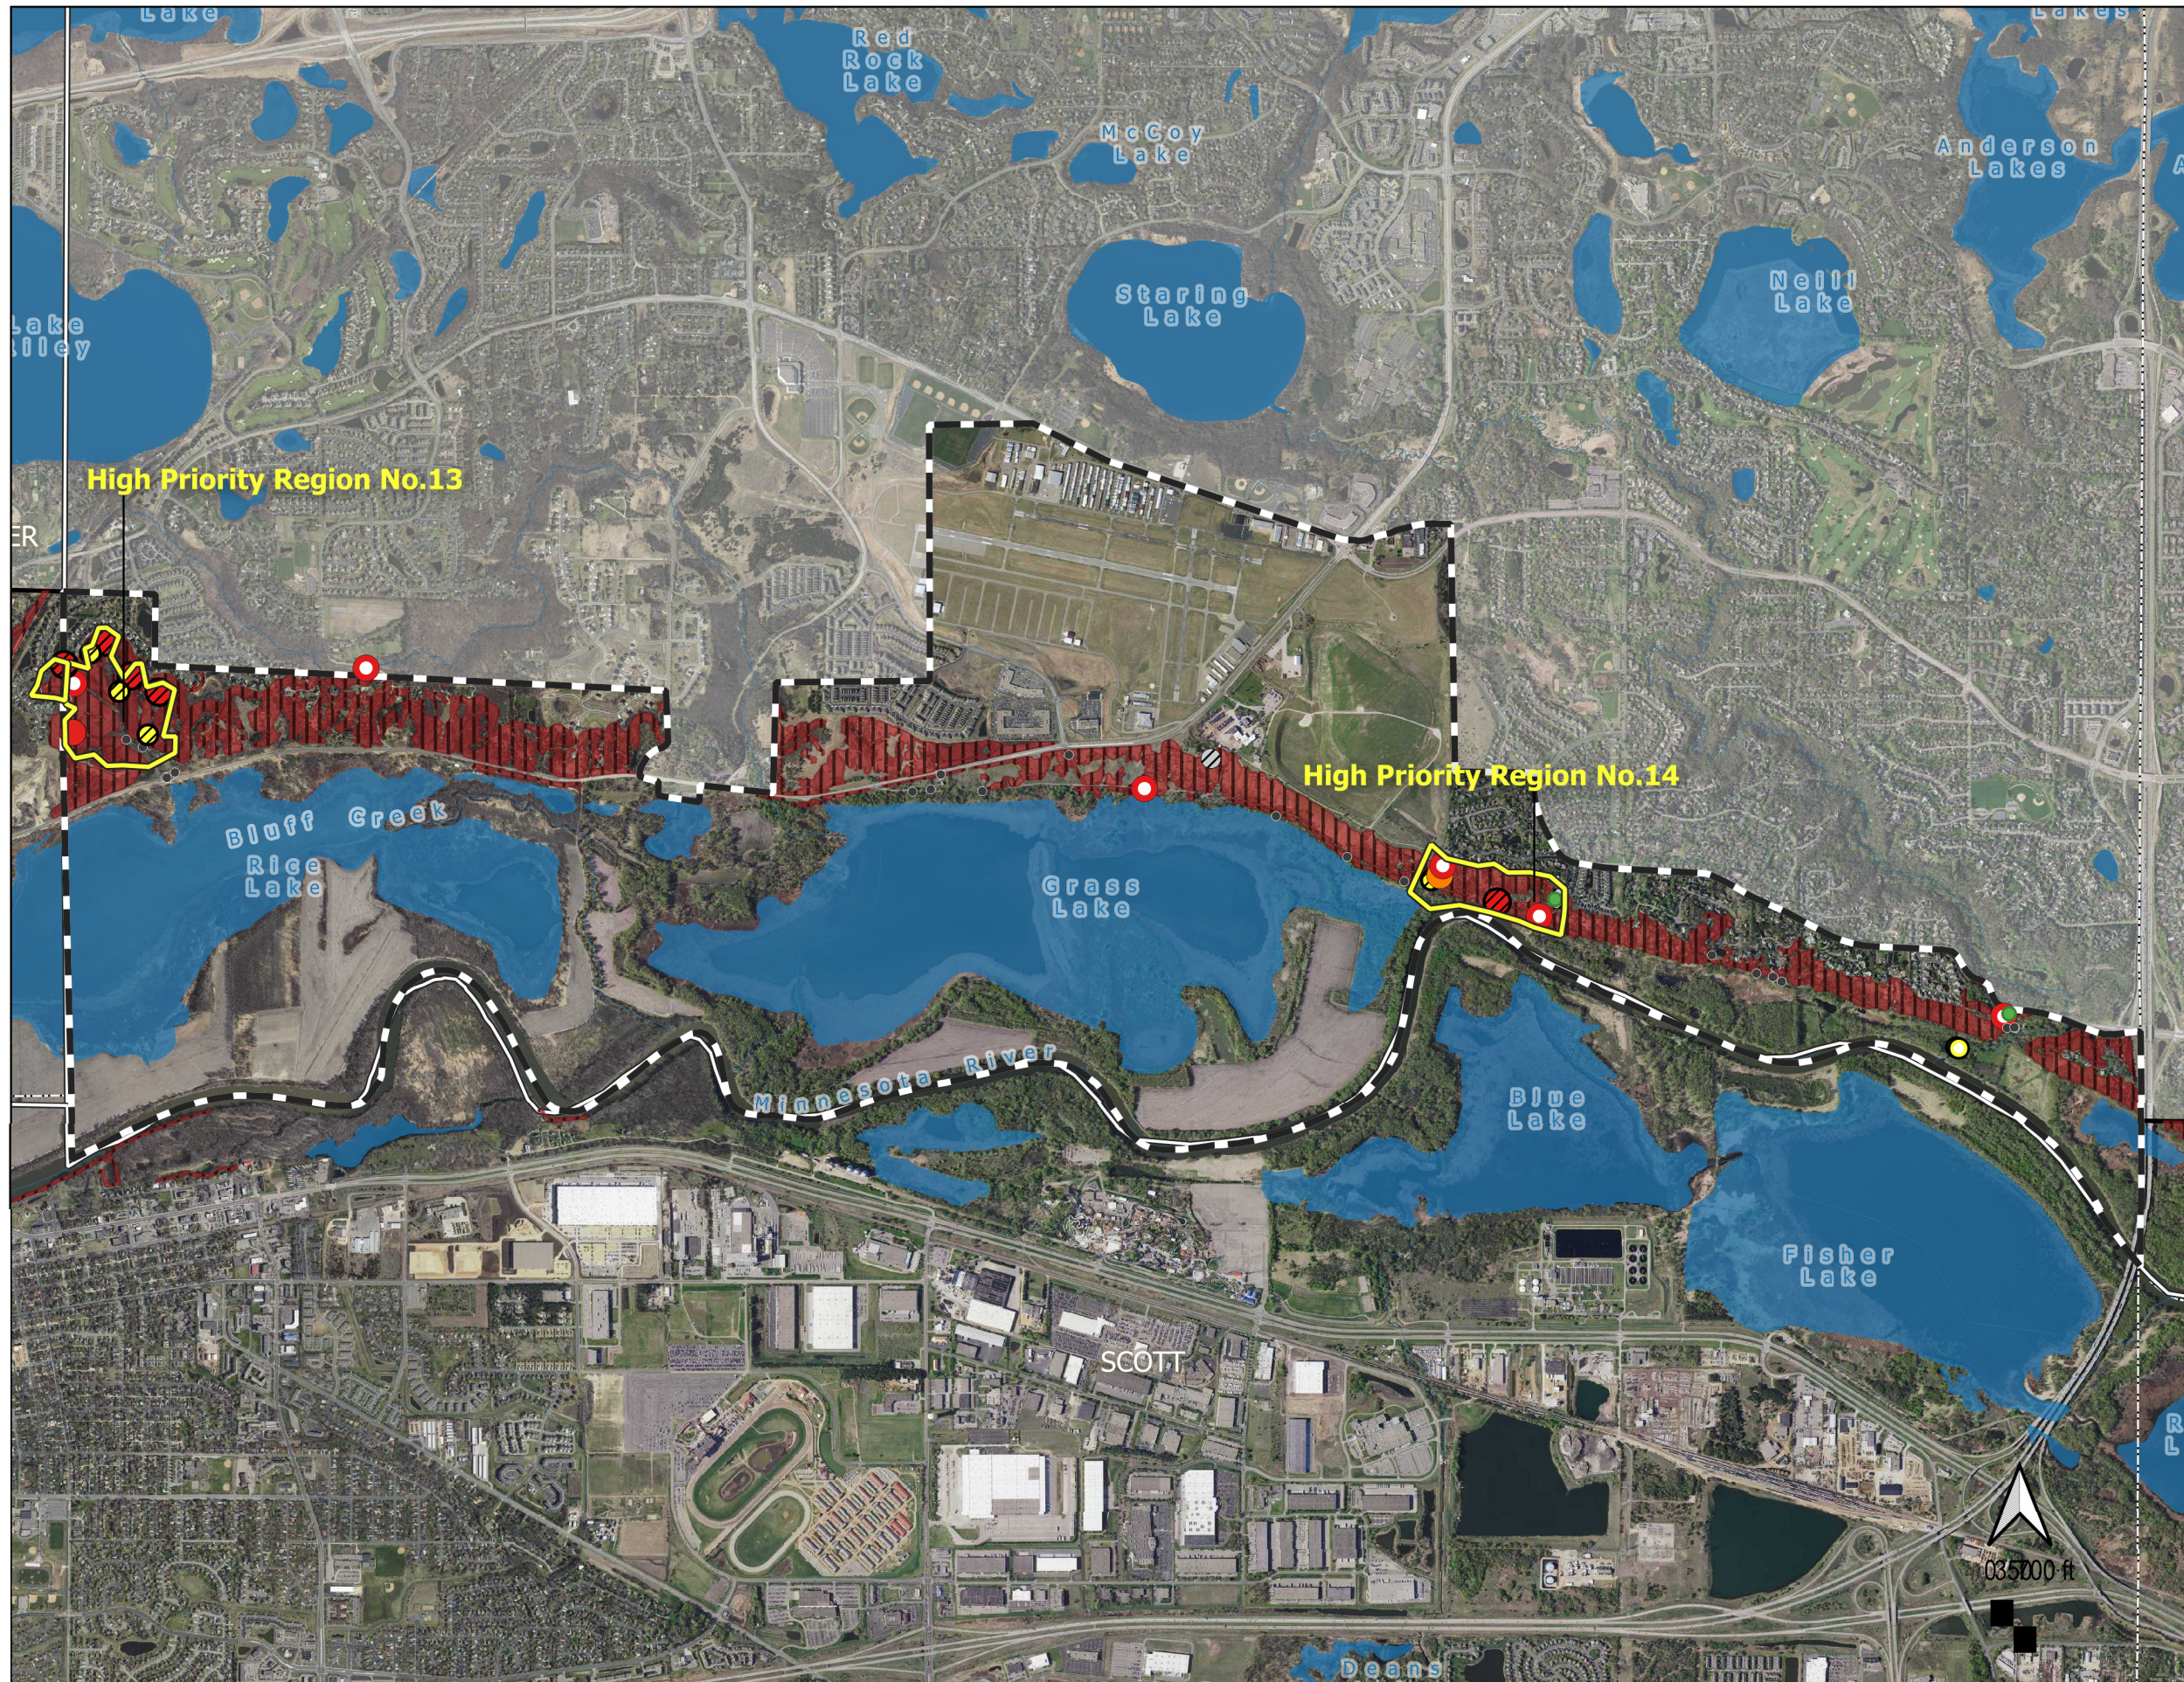
**Figure 94:
Eden Prairie Erosion
Progression and HPRs**

To better assess the erosion progression of an individual site, the change in erosion potential is mapped in **Figure 94**. There were six sites in Eden Prairie that changed erosion potential from the 2008 Inventory to the 2020 Inventory. Four of the sites have increased in their erosion potential, moving from moderate or low erosion potential to high erosion potential; these are discussed in more detail within their respective HPRs. Two other gullies were observed to have a reduced erosion potential: one from high to low and one from moderate to low. High priority was placed on the sites that became more severe between the 2008 and 2020 studies. The ranking of sites in less-severe categories owes largely to the limited information available from the 2008 study for ranking determinations, with the more appropriate ranking of the sites in the 2020 study attributable in part to improved data collection rather than any significant progressive change in conditions.

Three HPRs have been identified within the City of Eden Prairie. All the high-priority sites are in the steep slopes district (**Figure 94**).

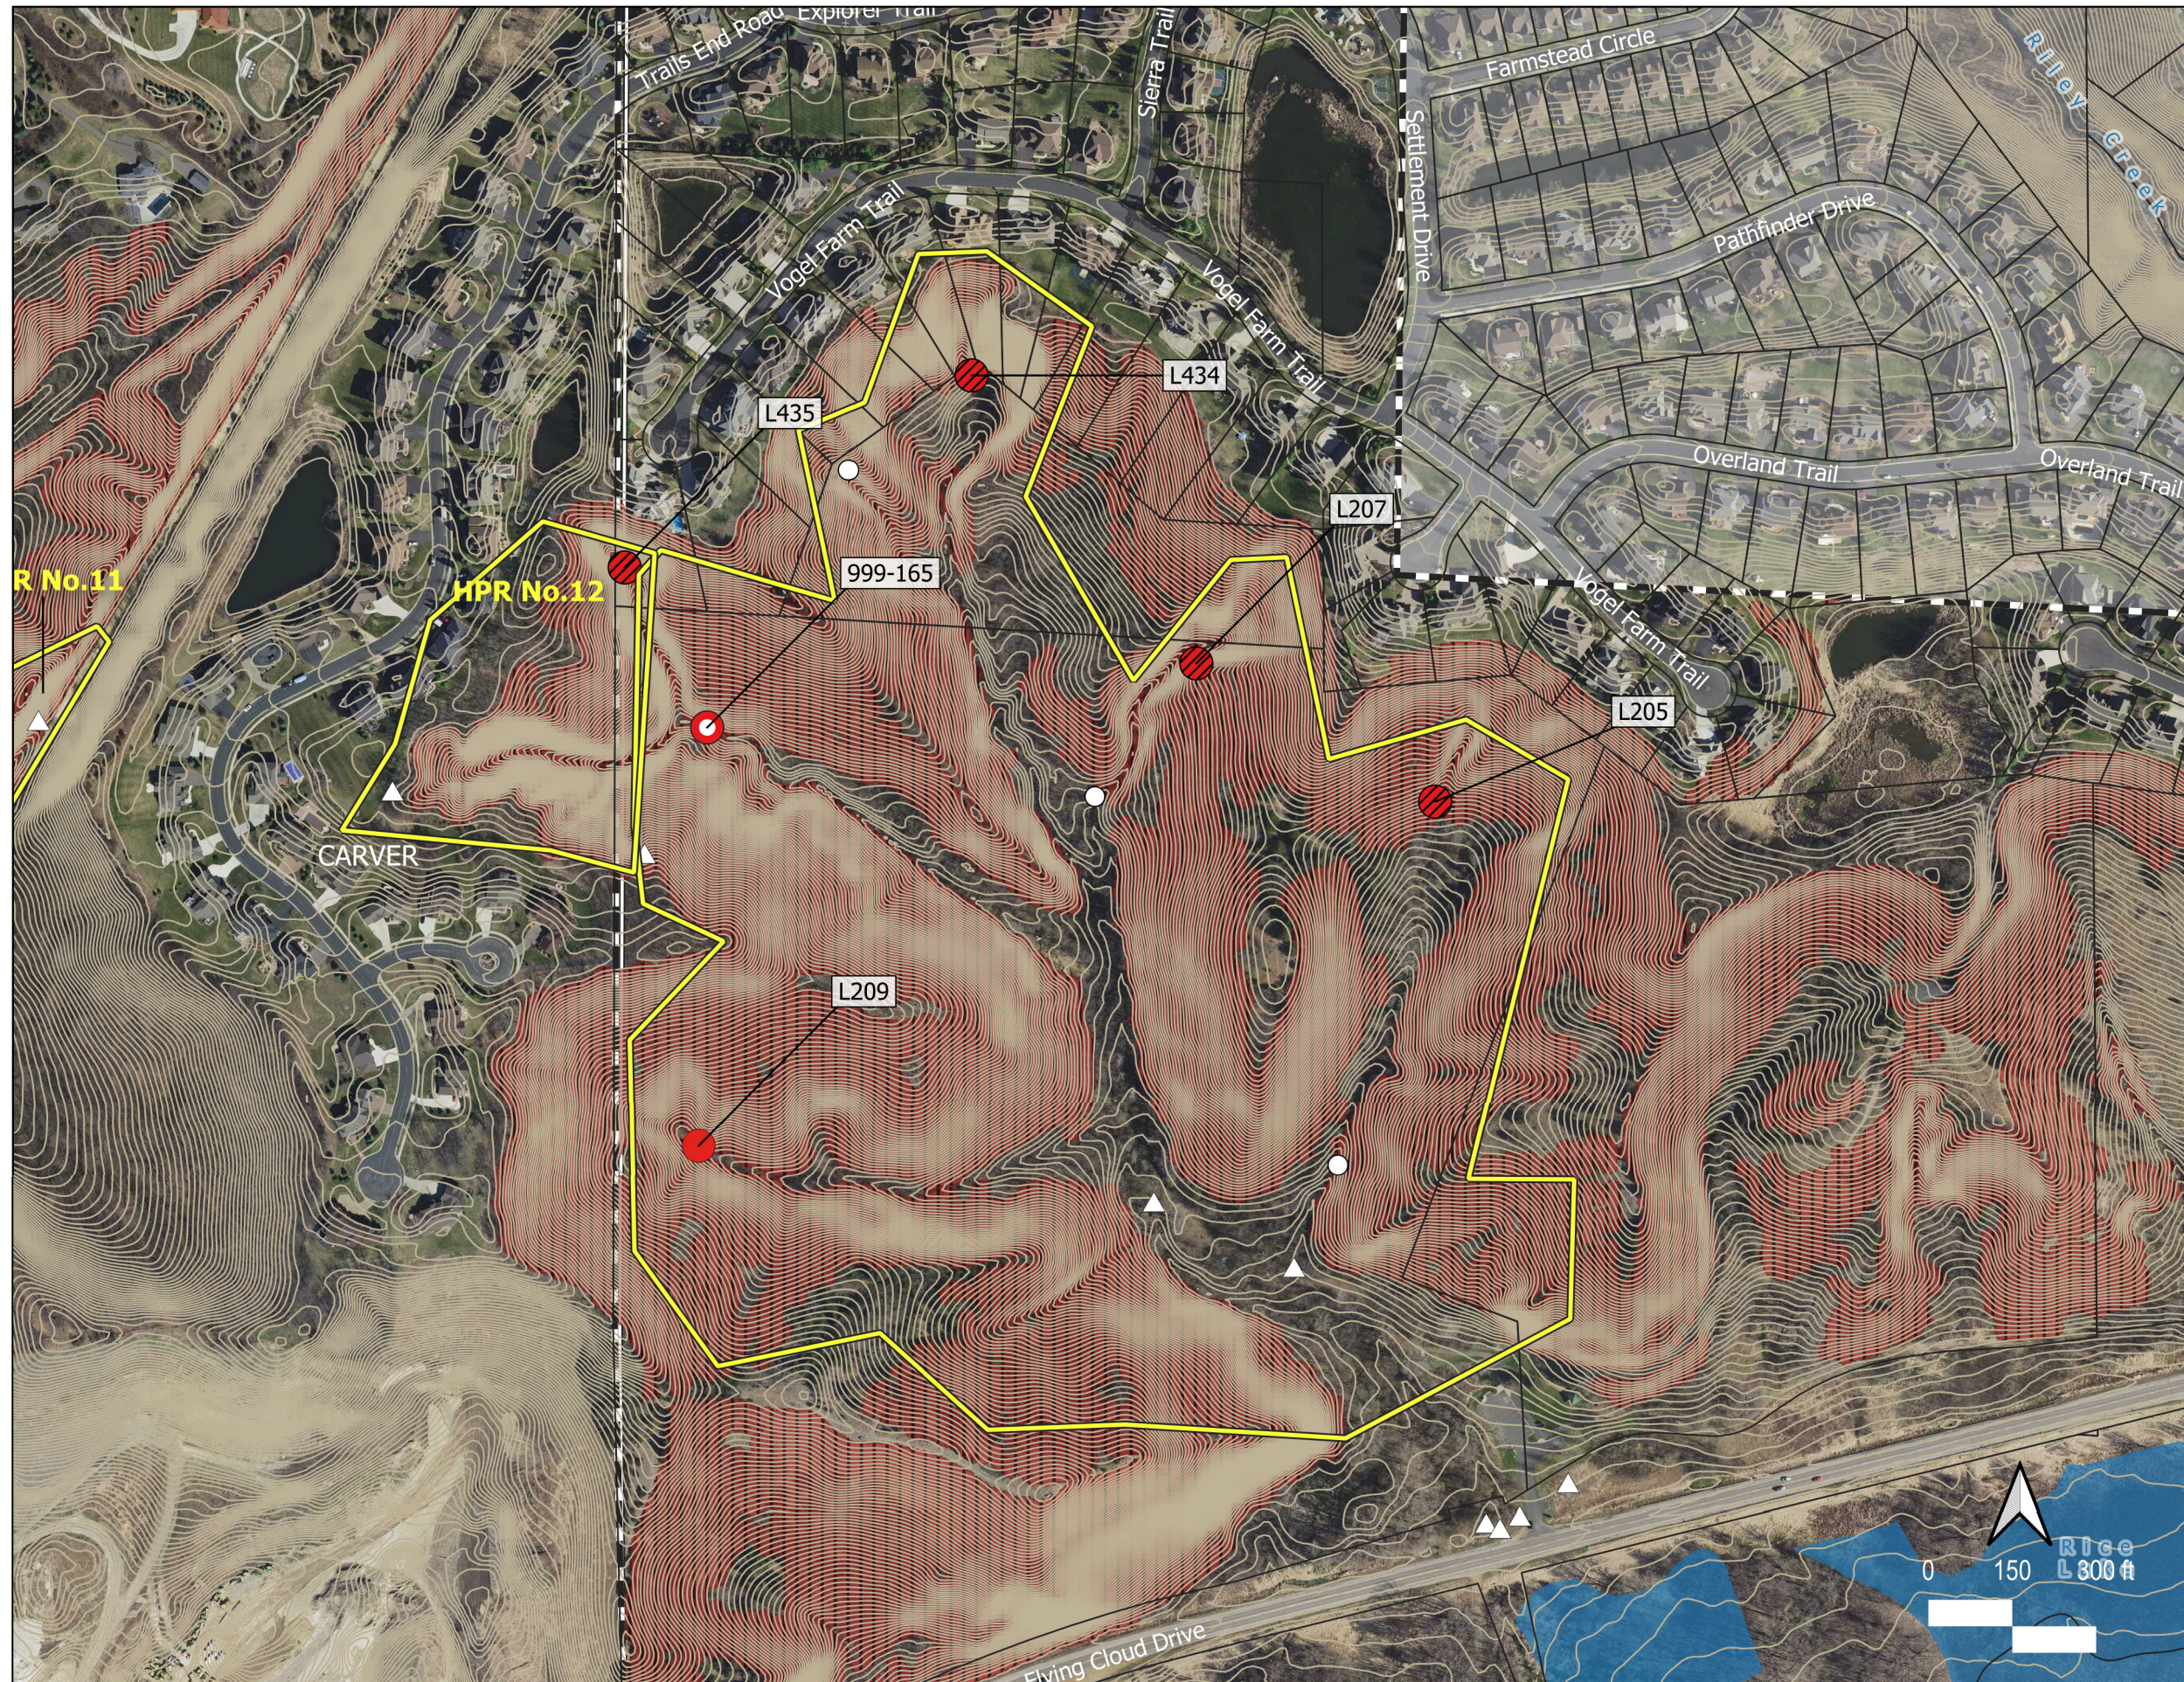
**Figure 95:
Eden Prairie High
Priority Region No. 13**

HPR 13 consists of Gullies L209, 999-165, L434, L207, and L205 (**Figure 95**). Each gully listed formed the head cut of a branch that connected downstream to a central stream flowing through the center of the Richard T. Anderson Conservation Area. The field team noted groundwater and V-shaped gullies with bare soil underneath overhanging banks as common characteristics in this region. Generally, groundwater seeps and steep slopes with dense canopies caused further erosion in the gullies at this site.

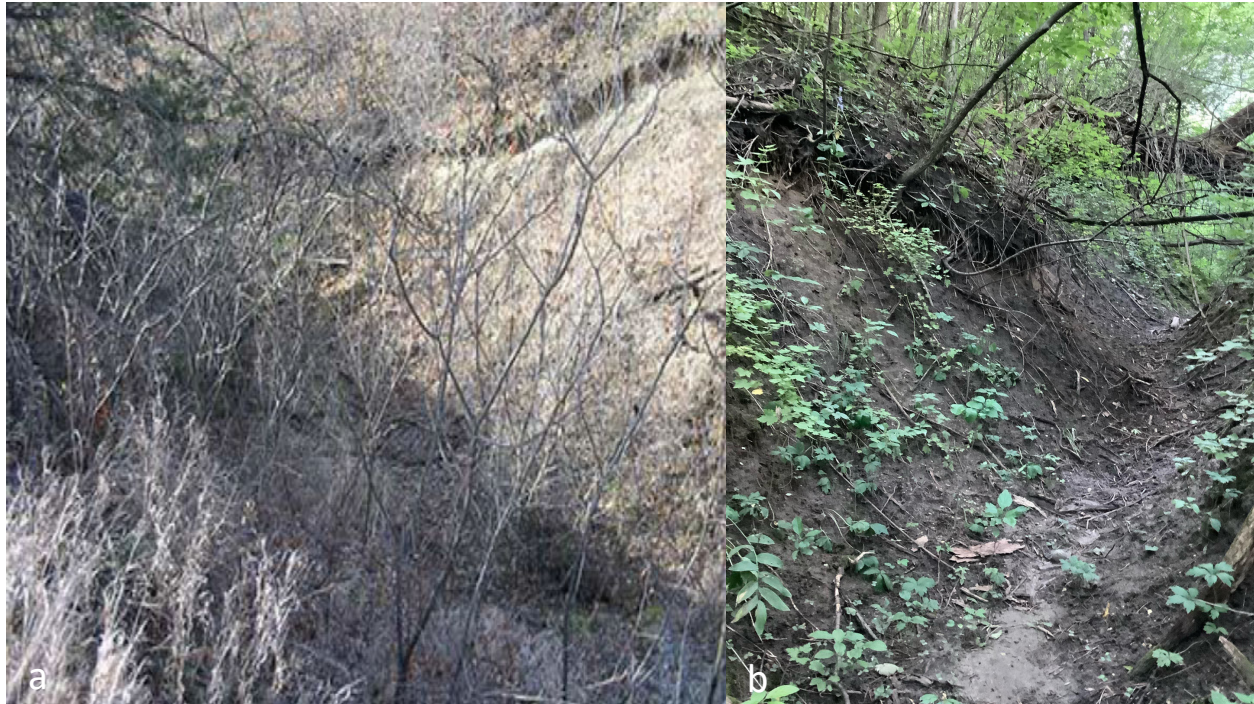
The 2008 Inventory described severe erosion, ferrous springs, and proximity of the gullies to residential homes at three of the sites in this HPR. Based on the comments and incision visible in the pictures, the desktop analysis ranked those three gullies as having high erosion potential in 2008. In 2020, the field team remained consistent with the 2008 Inventory and ranked the three gullies as still having high erosion potential. Site L205 in **Figure 96** shows the comparison of L205 between the two studies.

Figure 96. View of Site L205 from 2008 ('a') to 2020 ('b').

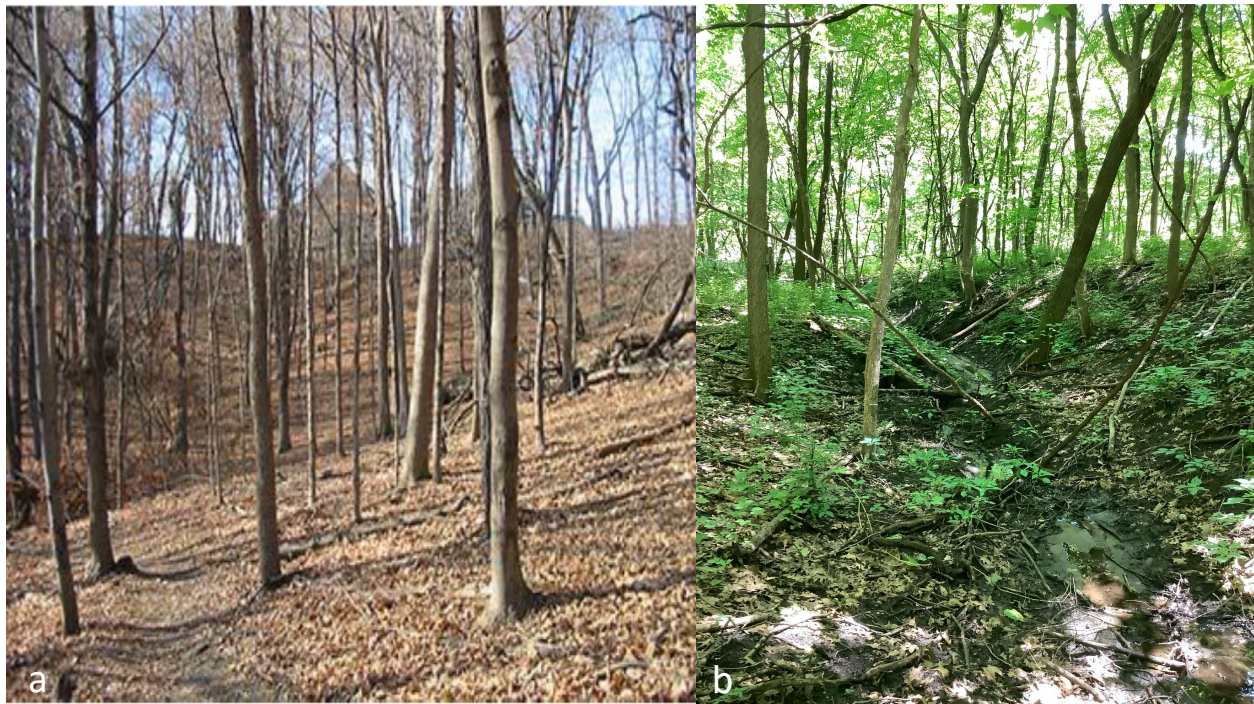
Based on the 2008 picture and note about “little erosion” at Site L209, the fourth gully in the HPR was ranked as having low erosion potential in 2008 during the desktop analysis. However, during the 2020 field visit, the team noted incision, groundwater, and unstable banks. These problem indicators, as well as the steep bank slopes near the more stabilized head cut, led to a high erosion potential rating. Between 2008 and 2020, the head cut banks appeared to have remained stable, while the channel eroded down. Additionally, a long section of incision was found further downstream from the head cut that showed the most severe signs of erosion in the gully. A comparison of the gully conditions over time appears in **Figure 97**; **Figure 97b** highlights the leaning trees and channel incision seen in 2020, signifying increased erosion in the gully between studies.

Figure 97. Photo 'a' is a view of L209's head cut area taken in 2008. Photo 'b' is a downstream view of L209 taken in 2020.

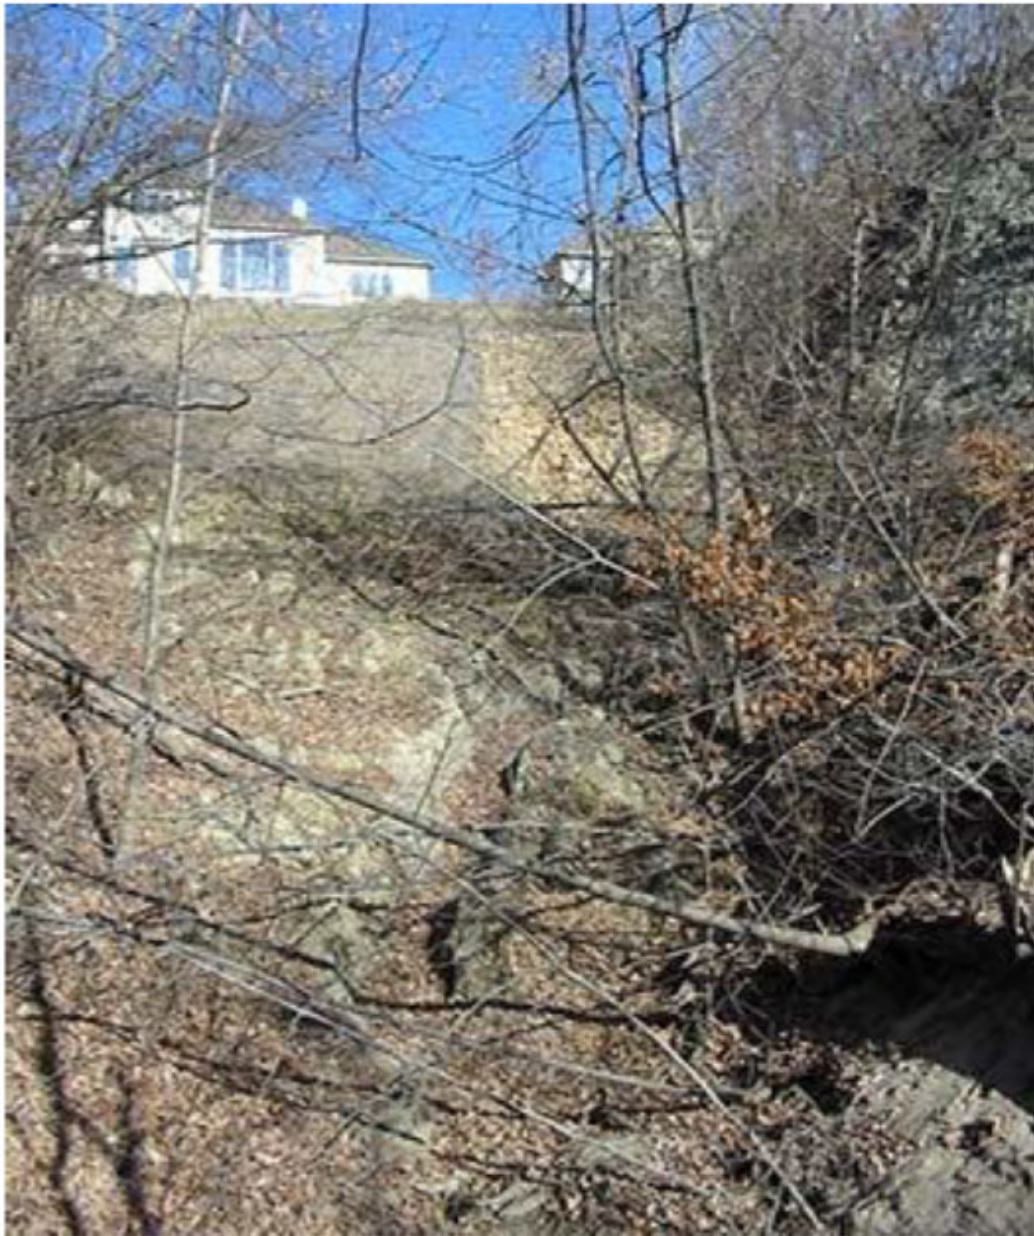
Figure 98. Photo of Site L434 from 2008 Inventory.

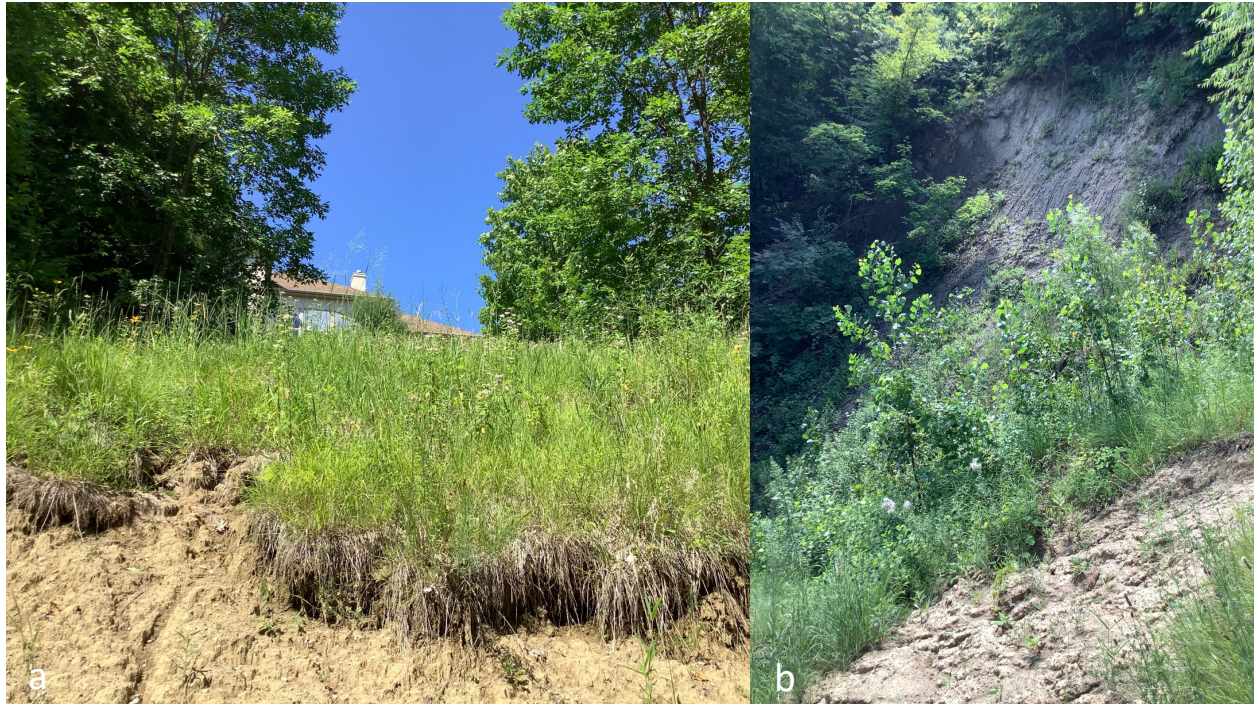
At the northern part of the Richard T. Anderson Conservation Area, L434 presented a unique gully case. It seems possible that between 2008 and 2020, stabilization efforts occurred along the slope behind a house. However, at the time of the 2020 field visit, large sections of vegetation were slumping off the hillslope towards the head cut of the stream, which occurred at an eroding area of ferrous groundwater seeps. Thus, the area was still ranked as having high erosion potential and appeared to have been the site of unsuccessful stabilization. **Figure 98** shows an upstream view of the gully taken in 2008 before the restoration was completed; **Figure 99** shows the gully in 2020. **Figure 99a** is a view of slumping and bare soil along the head cut. **Figure 99b** is a downstream view of bare soil and steep valley walls.

Figure 99. Photos of Site L434 from 2020 Inventory.

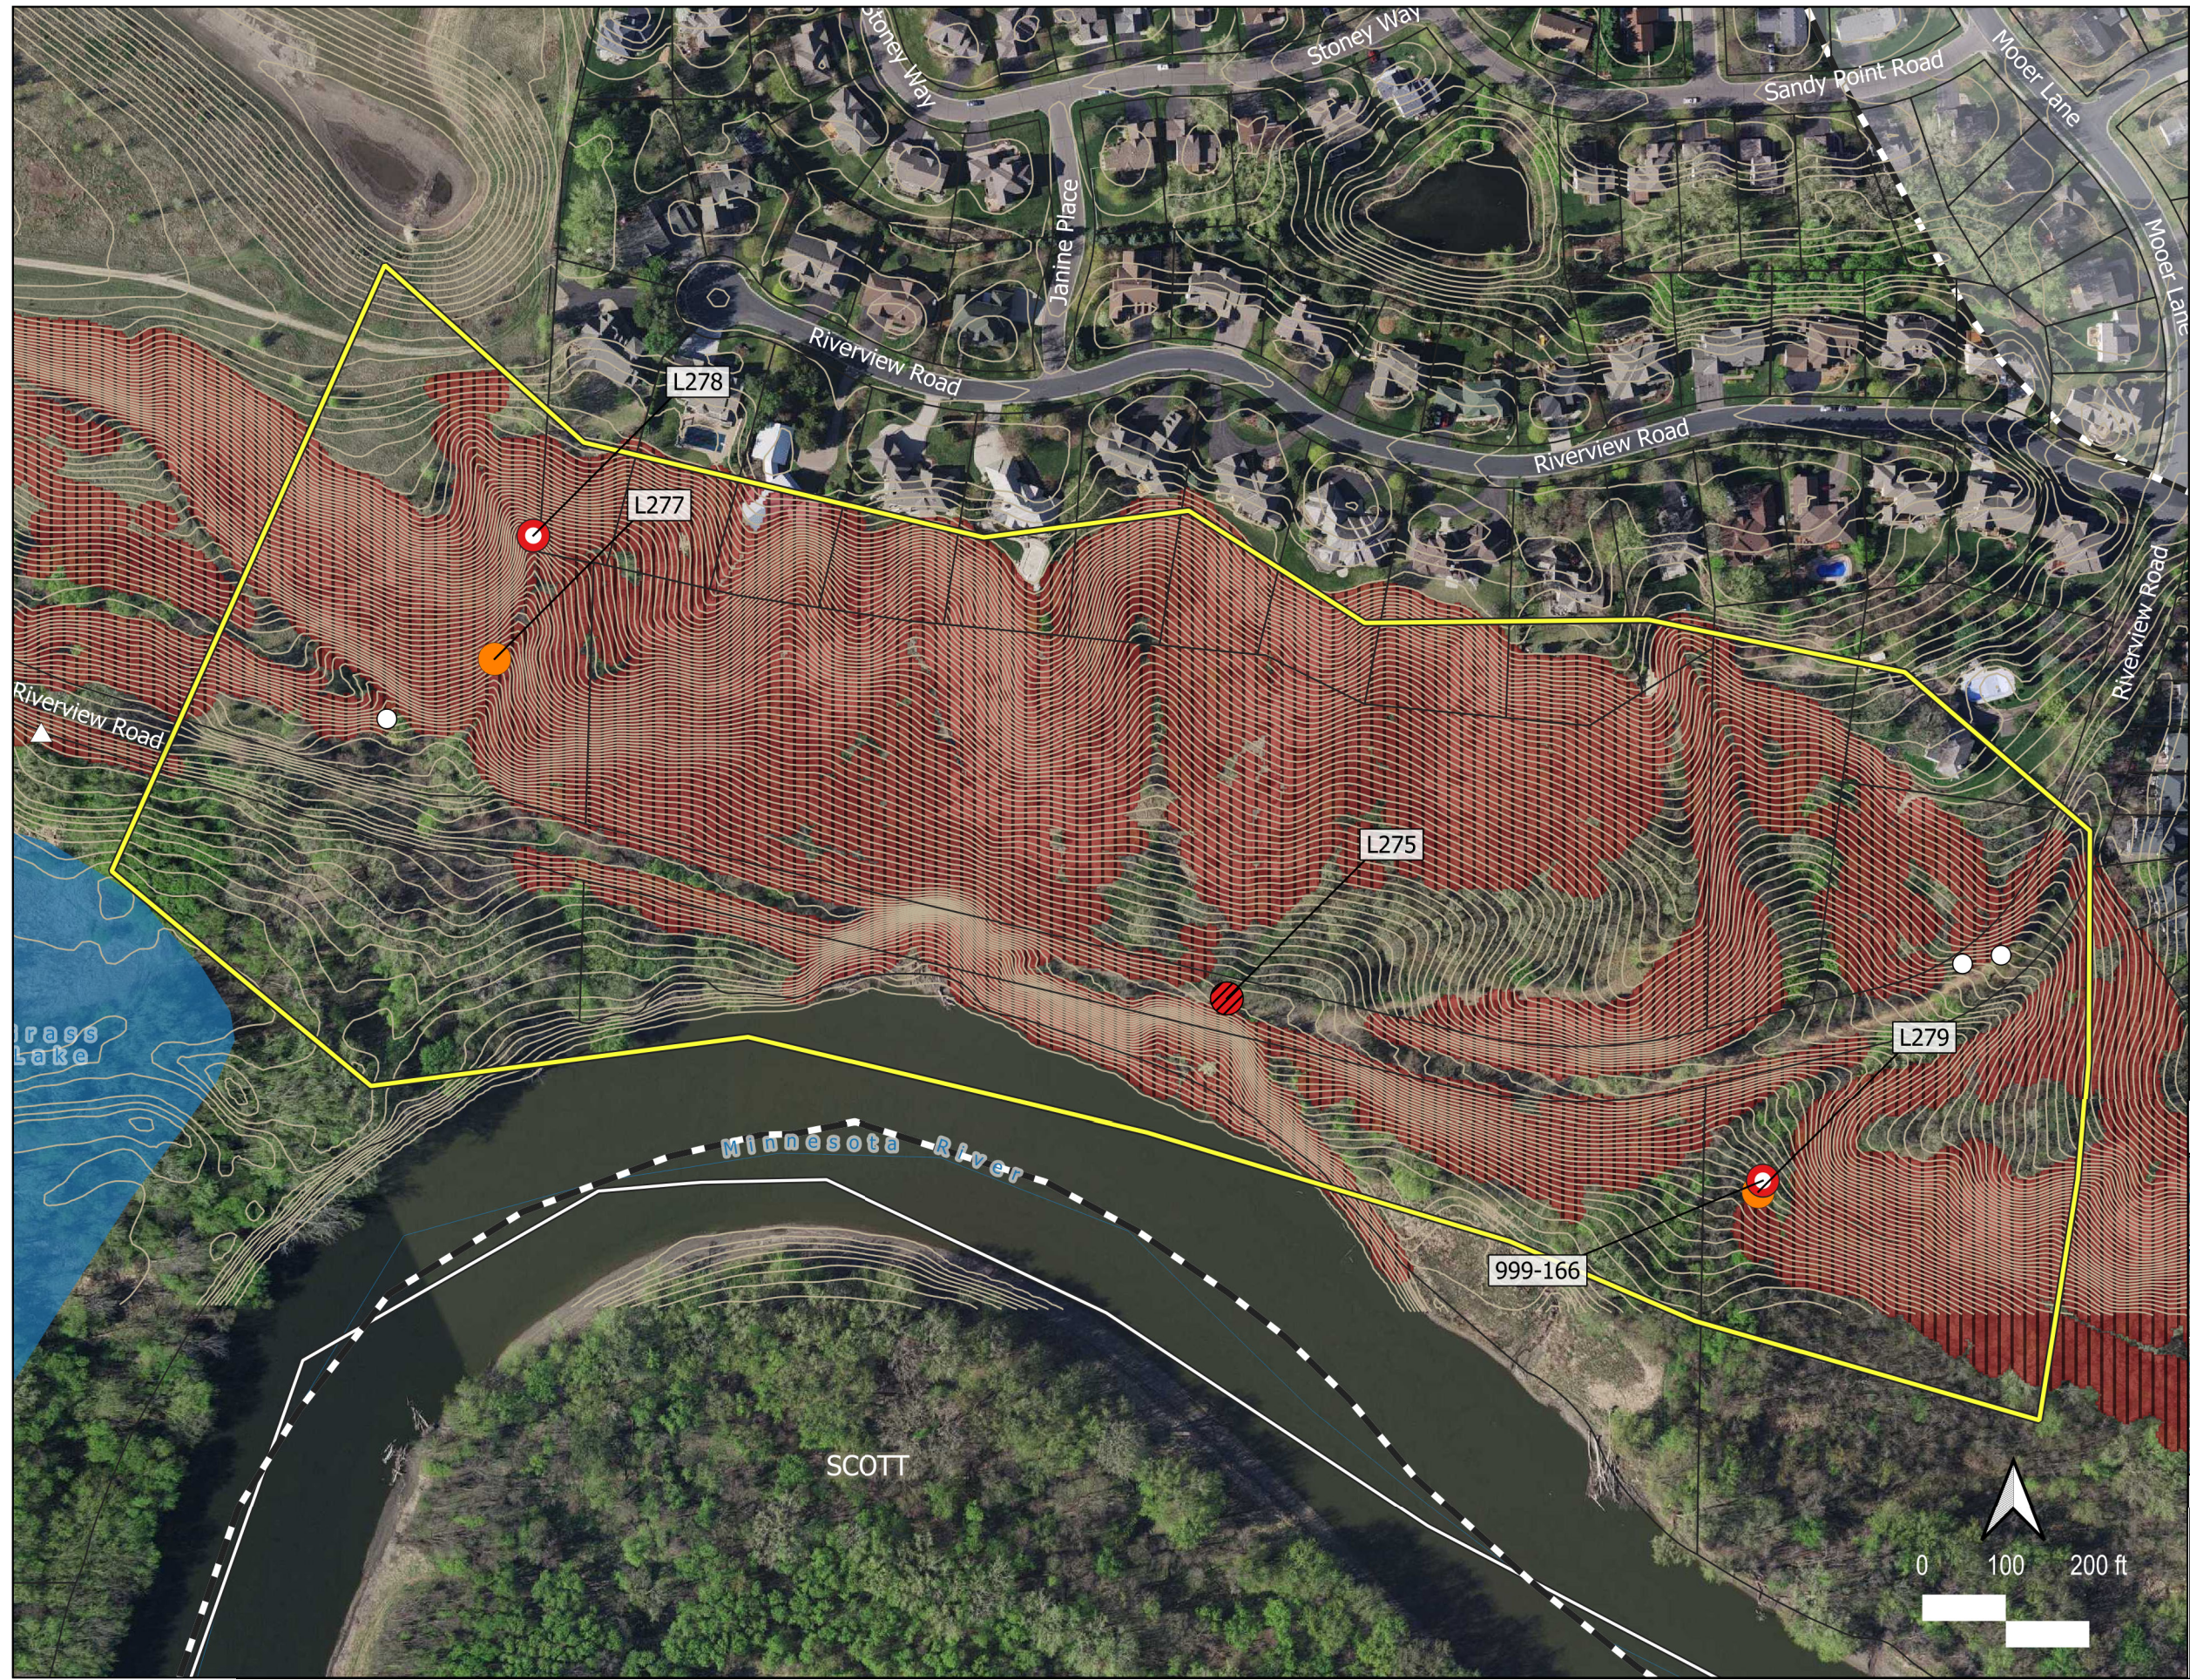
**Figure 100:
Eden Prairie High
Priority Region No. 14**

HPR 14 is located along the banks of the Minnesota River. The region includes two channels consisting of two gully sites each, and one large slump along the Minnesota River (**Figure 100**).

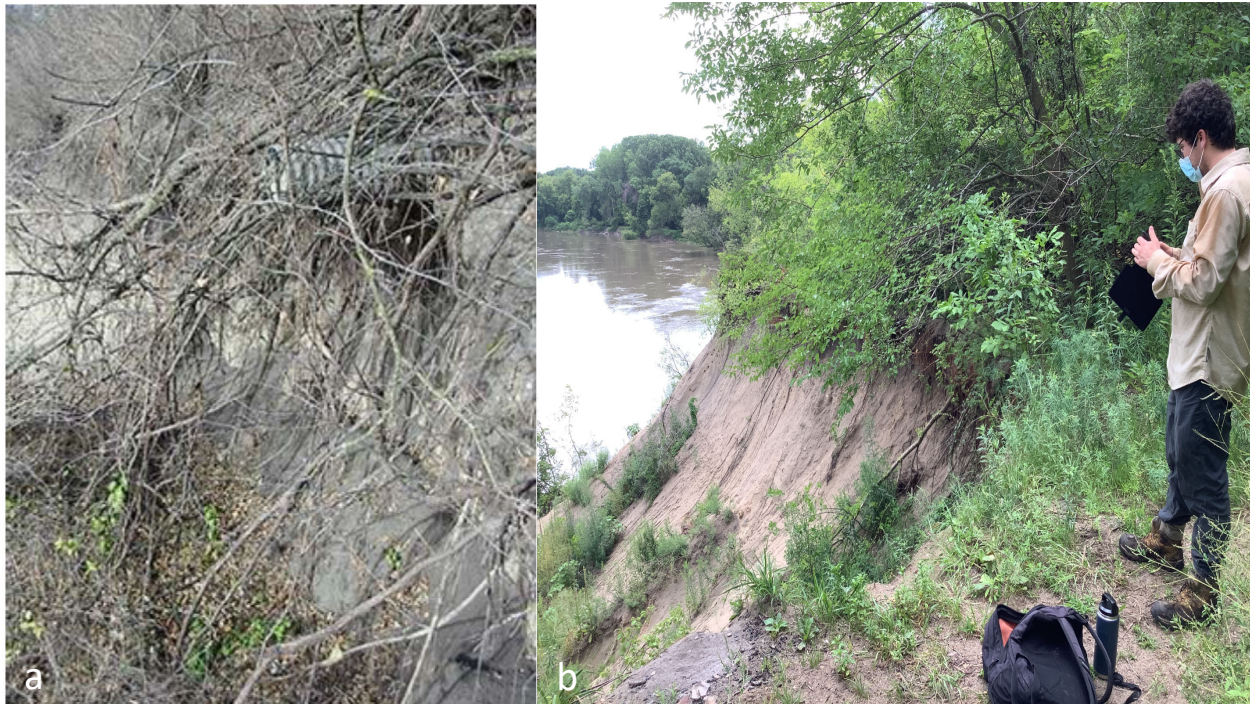
L275 was noted as having high erosion potential in the 2008 study due to the bare soil noted around the pipe in the picture taken by the field team. At the time of the 2020 site visit, the field team could not safely reach the pipe outfall to clearly assess it because of unstable slopes, which indicates the amount of erosion that occurred along the bank since 2008. A comparison of the pipe outfall in 2008 and the bank erosion noted in the 2020 field work appears below in **Figure 101**.

Figure 101. Progression of erosion at Site L275 from 2008 (a) to 2020 (b).

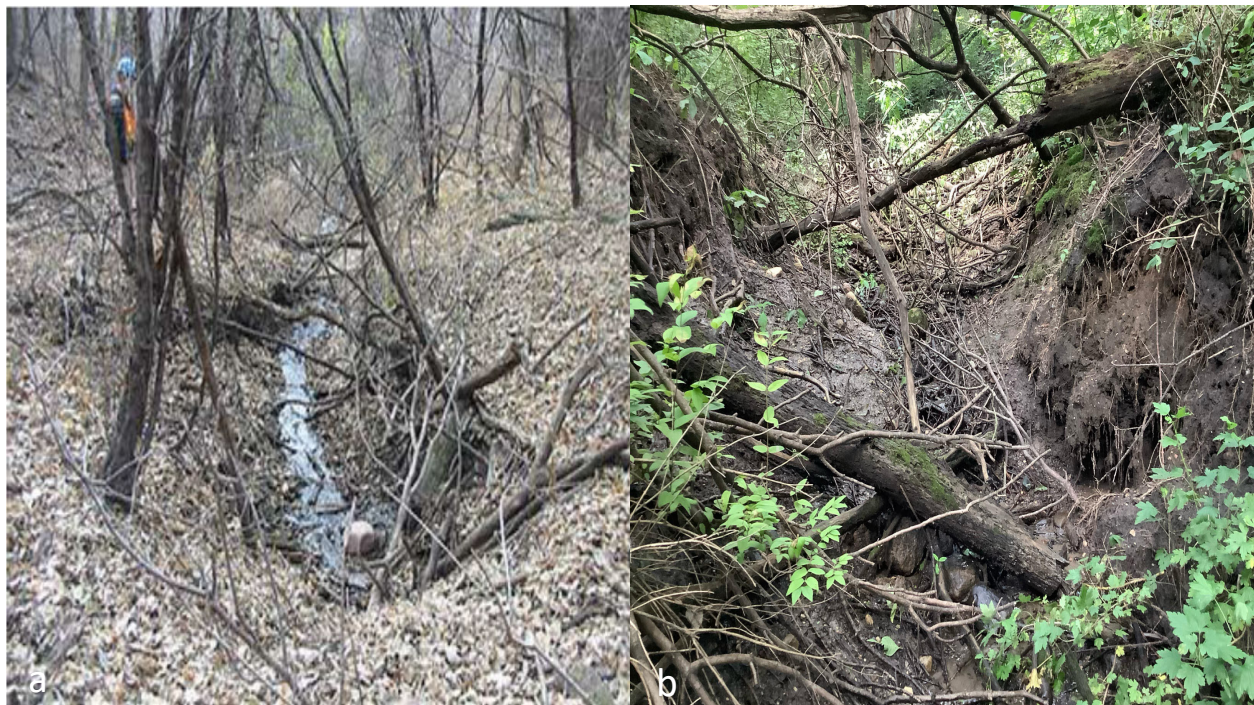
Factors contributing to the formation and erosion of the high-priority gullies in the region included groundwater seepage, steep slopes throughout Eden Prairie, and a dense canopy and subsequent lack of vegetation. Common problem indicators within these gullies included slumping, overhanging banks, and leaning trees. Incision was noted at sites L277 and L279. **Figure 102** below illustrates incision caused by groundwater at Site L277.

Figure 102. Comparison of Site L277 in 2008 (a) and 2020 (b).
