9.0 CITY OF EDEN PRAIRIE

9.4 Eden Prairie Gully Progression

9.5 Eden Prairie High-Priority Regions

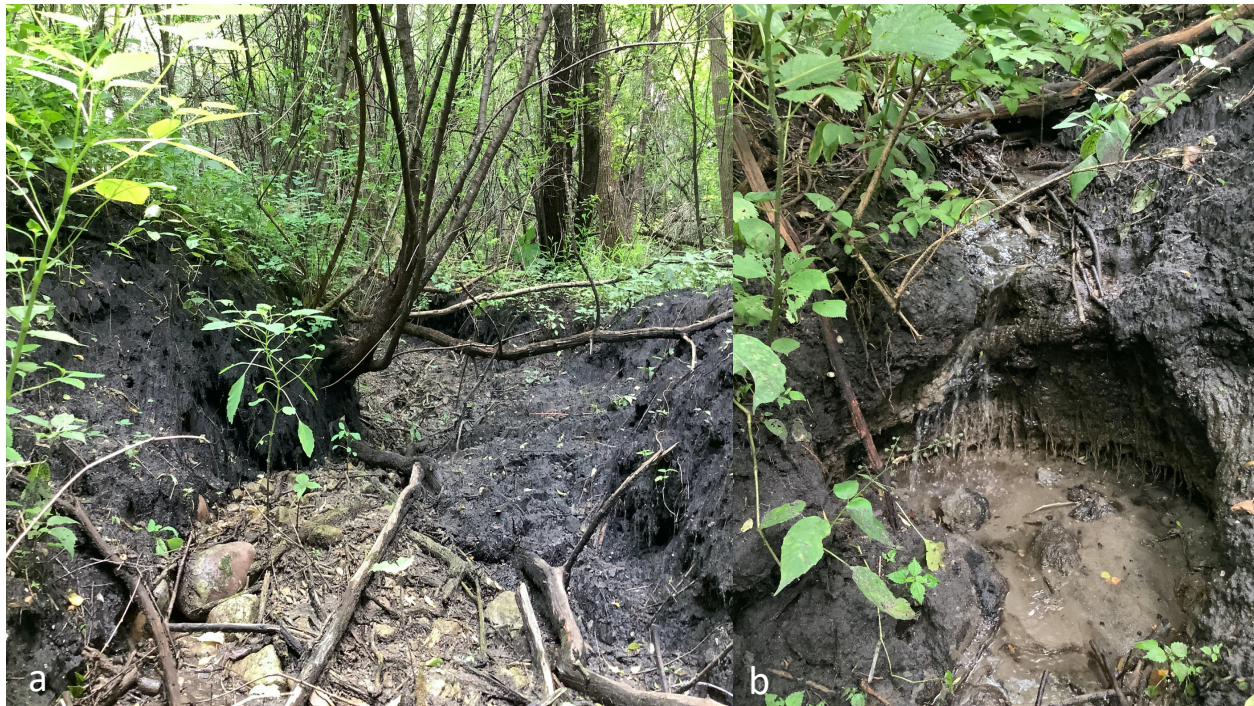
Sites L279 and 999-166 shared similar characteristics to L277. They were both incised channels formed from groundwater seeps with unstable, overhanging banks and active head cuts where seeps emerged. **Figure 103** shows the active erosion seen at L279 and 999-166 during field visits in 2020. **Figure 103b** also illustrates a large knickpoint within the channel of 999-166.

Figure 103. View of Sites L279 (a) and 999-166 (b) taken in 2020.

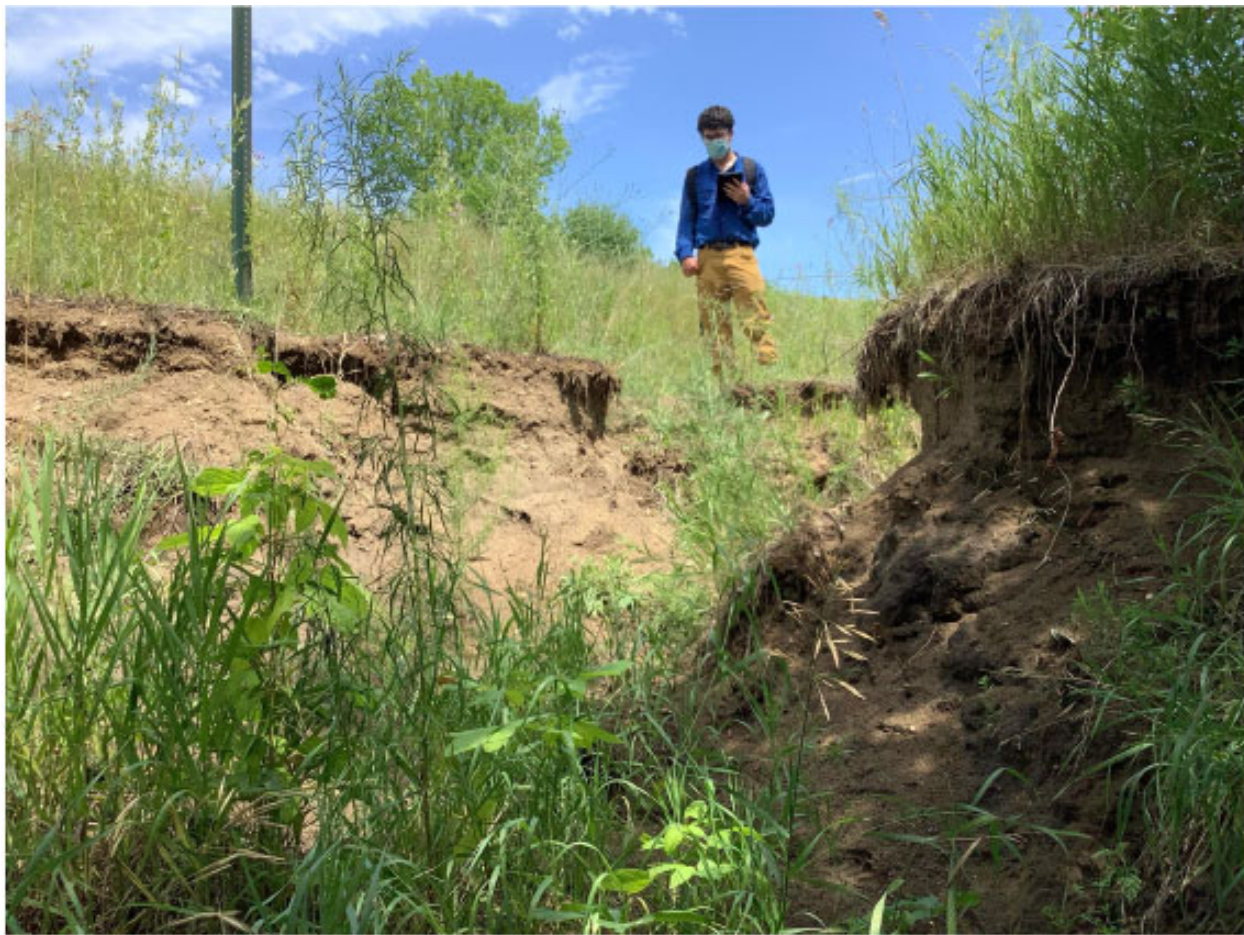
Gully 999-105 is an outlying point found along the Riverview Road trail. At this gully, advancing erosion is threatening an existing pedestrian walking trail, and bare sandy banks are exposed (**Figure 104**).

Further slumping looks imminent; overhanging banks line the top perimeter of the gully. The field team was unable to determine the cause of the erosion, but the steep slopes along the hillslope may be exacerbating the speed at which this headward erosion and migration is occurring.

Figure 104. View of Gully 999-105 taken in 2020 looking upstream toward the pedestrian walking trail and gully head cut.

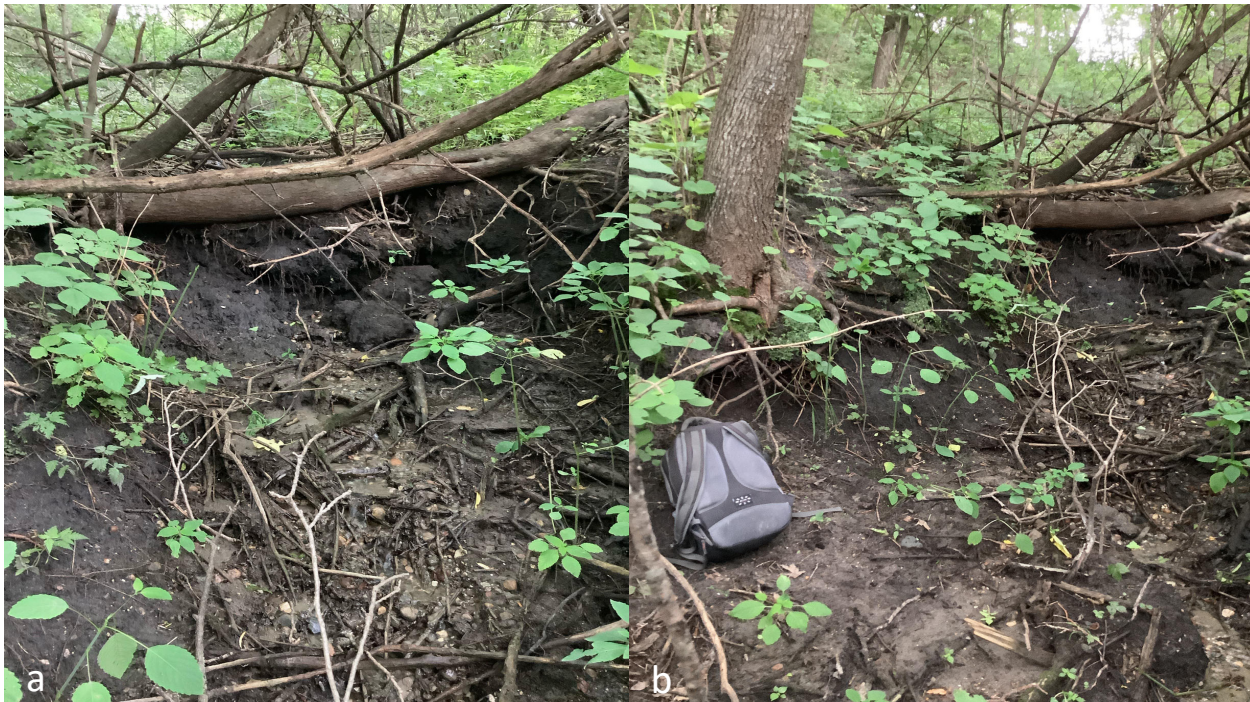
Problem indicators included slumping, a loss of bank vegetation, overhanging trees, and degradation visible in the incised sections of the gully channel. **Figure 105** below details the erosion, with **Figure 105a** showing the actively eroding head cut and seep and **Figure 105b** showing the overhanging banks and bare soil along an incised channel.

The apparent causes for the development of the gully include several groundwater seeps ringing the gully head cut, which are saturating and destabilizing the soil. Slumping and erosion may continue as trees along the banks continue to hang over the gully channel.

Figure 105. Photos of Gully 999-127 in 2020.
