9.0 CITY OF EDEN PRAIRIE

9.4 Eden Prairie Gully Progression

9.5 Eden Prairie High-Priority Regions

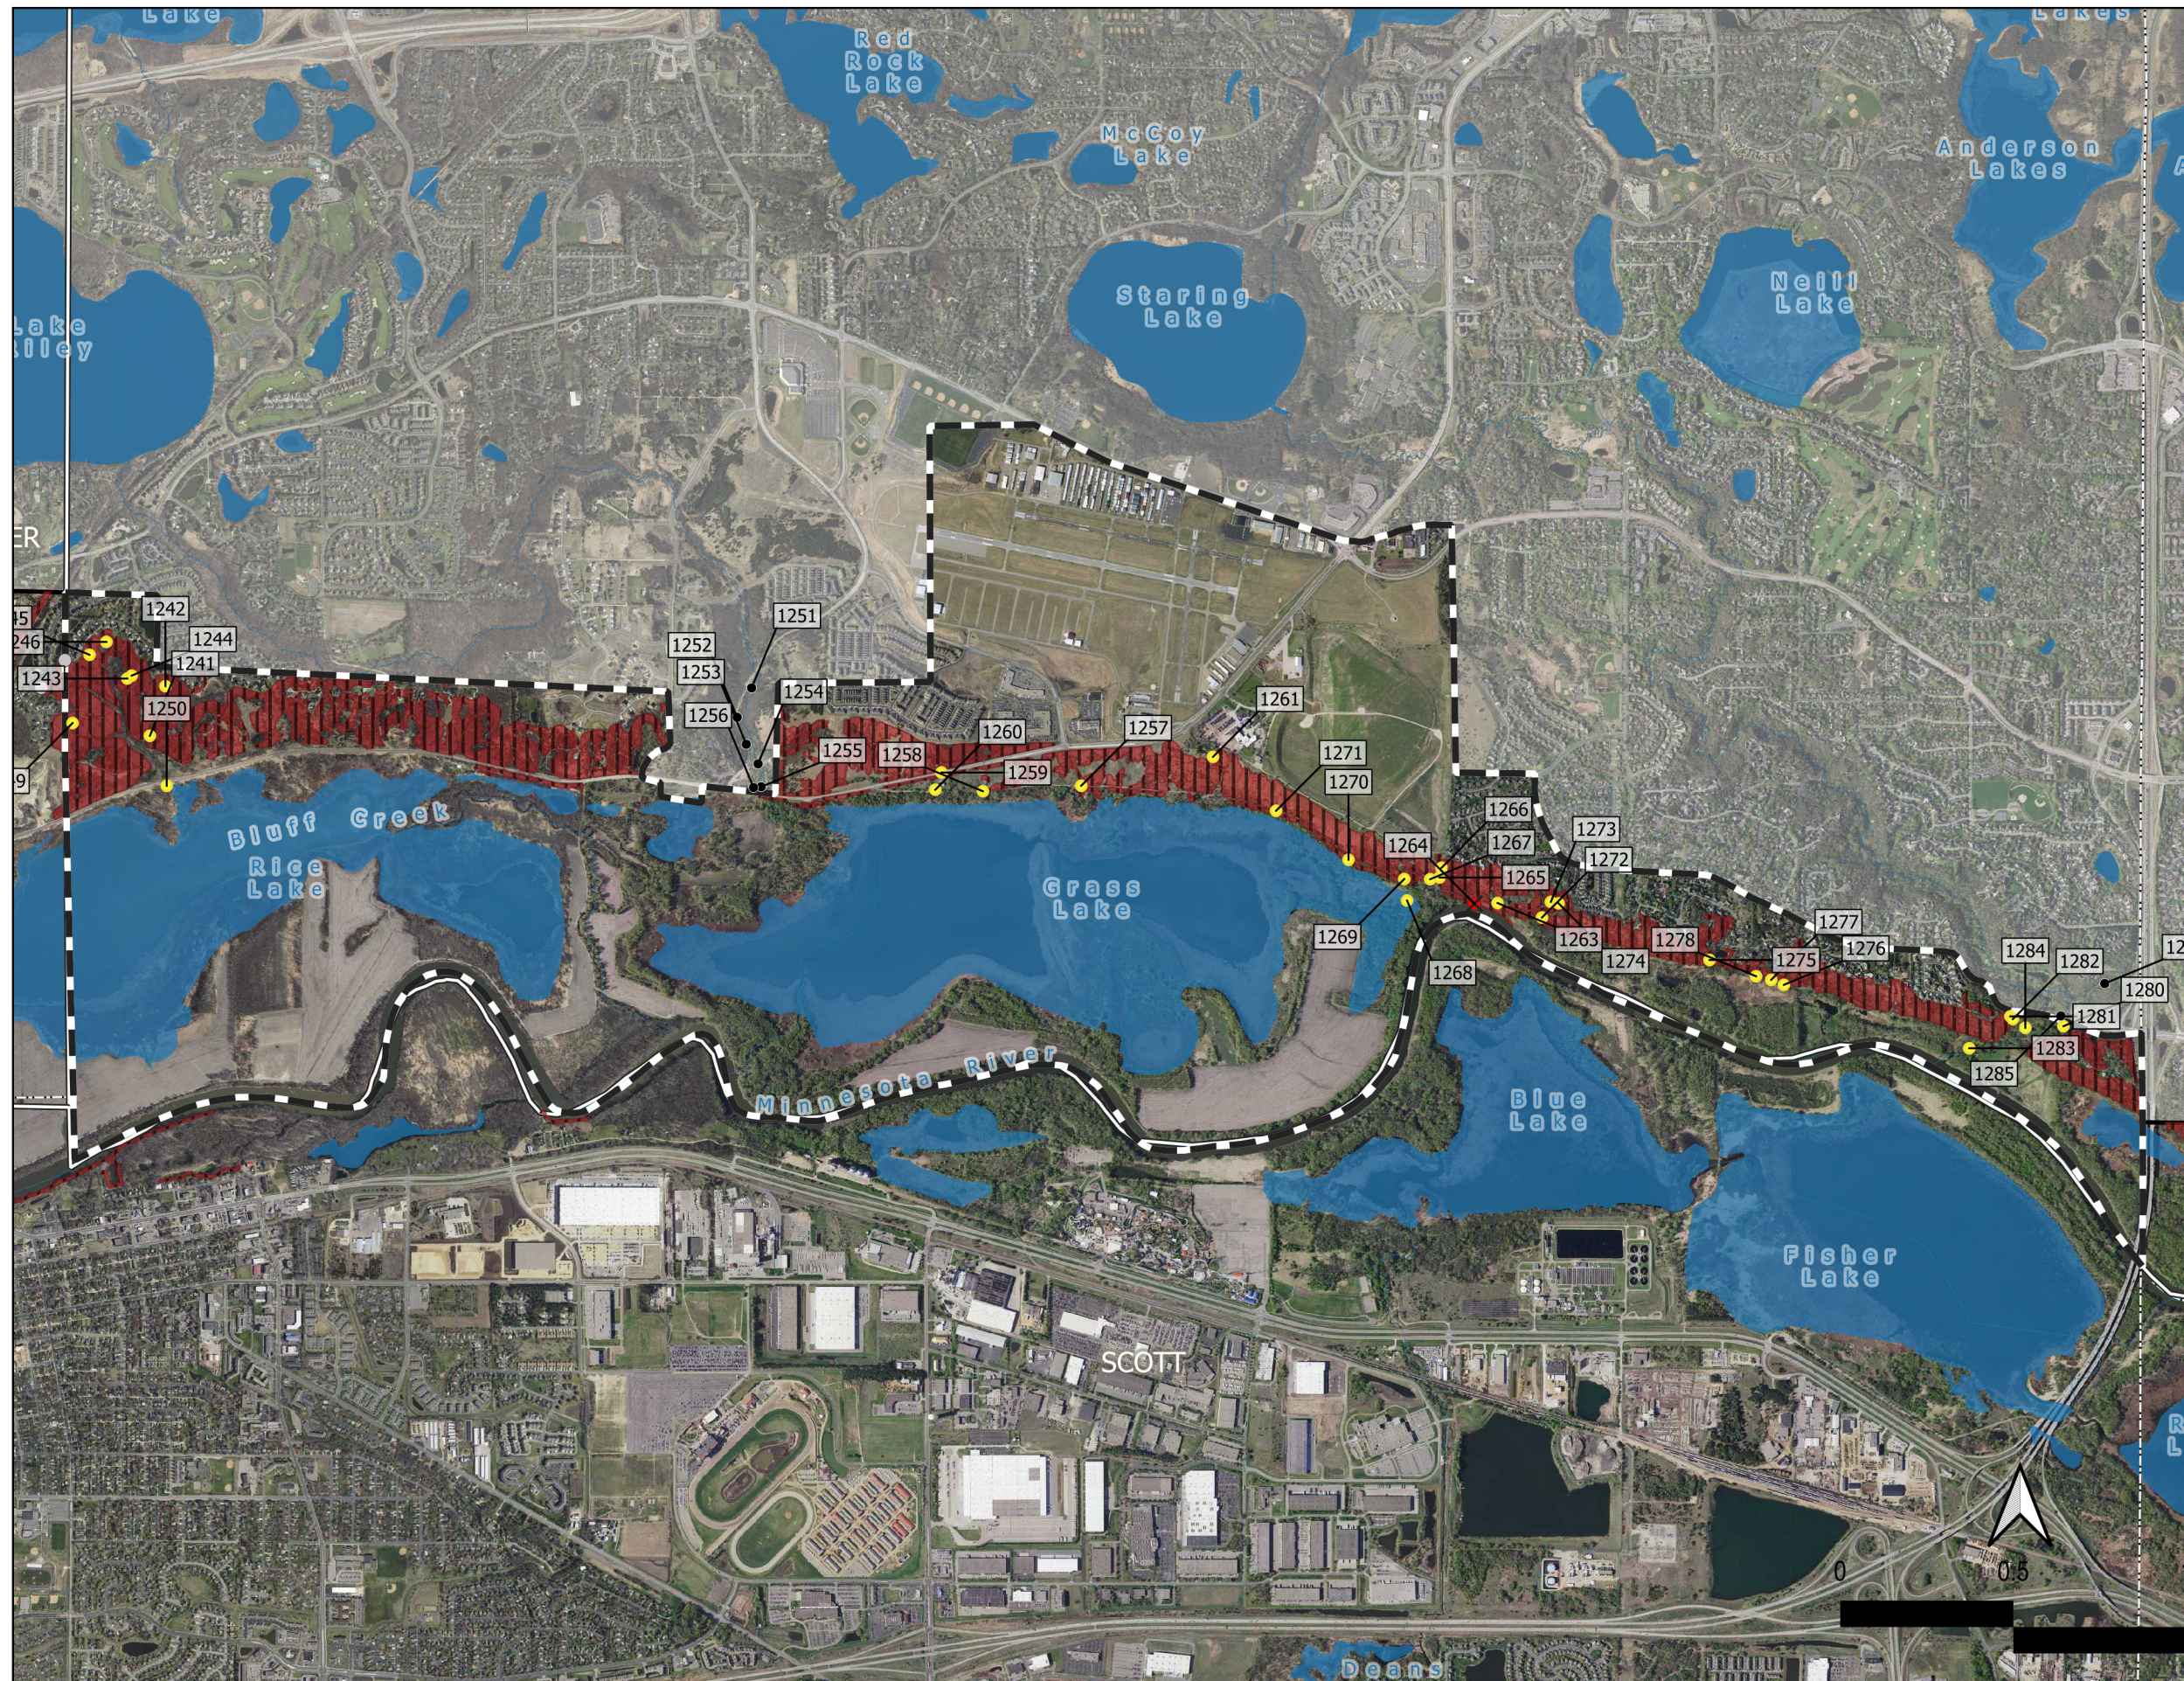
**Figure 90:
Eden Prairie 2008
Inventory Locations**

The 2008 Inventory identified 42 features within the City of Eden Prairie. Through the desktop analysis of the 2008 Inventory, one site was removed because it fell outside the LMRWD boundary and eight were determined to lie outside the District (**Figure 90**).

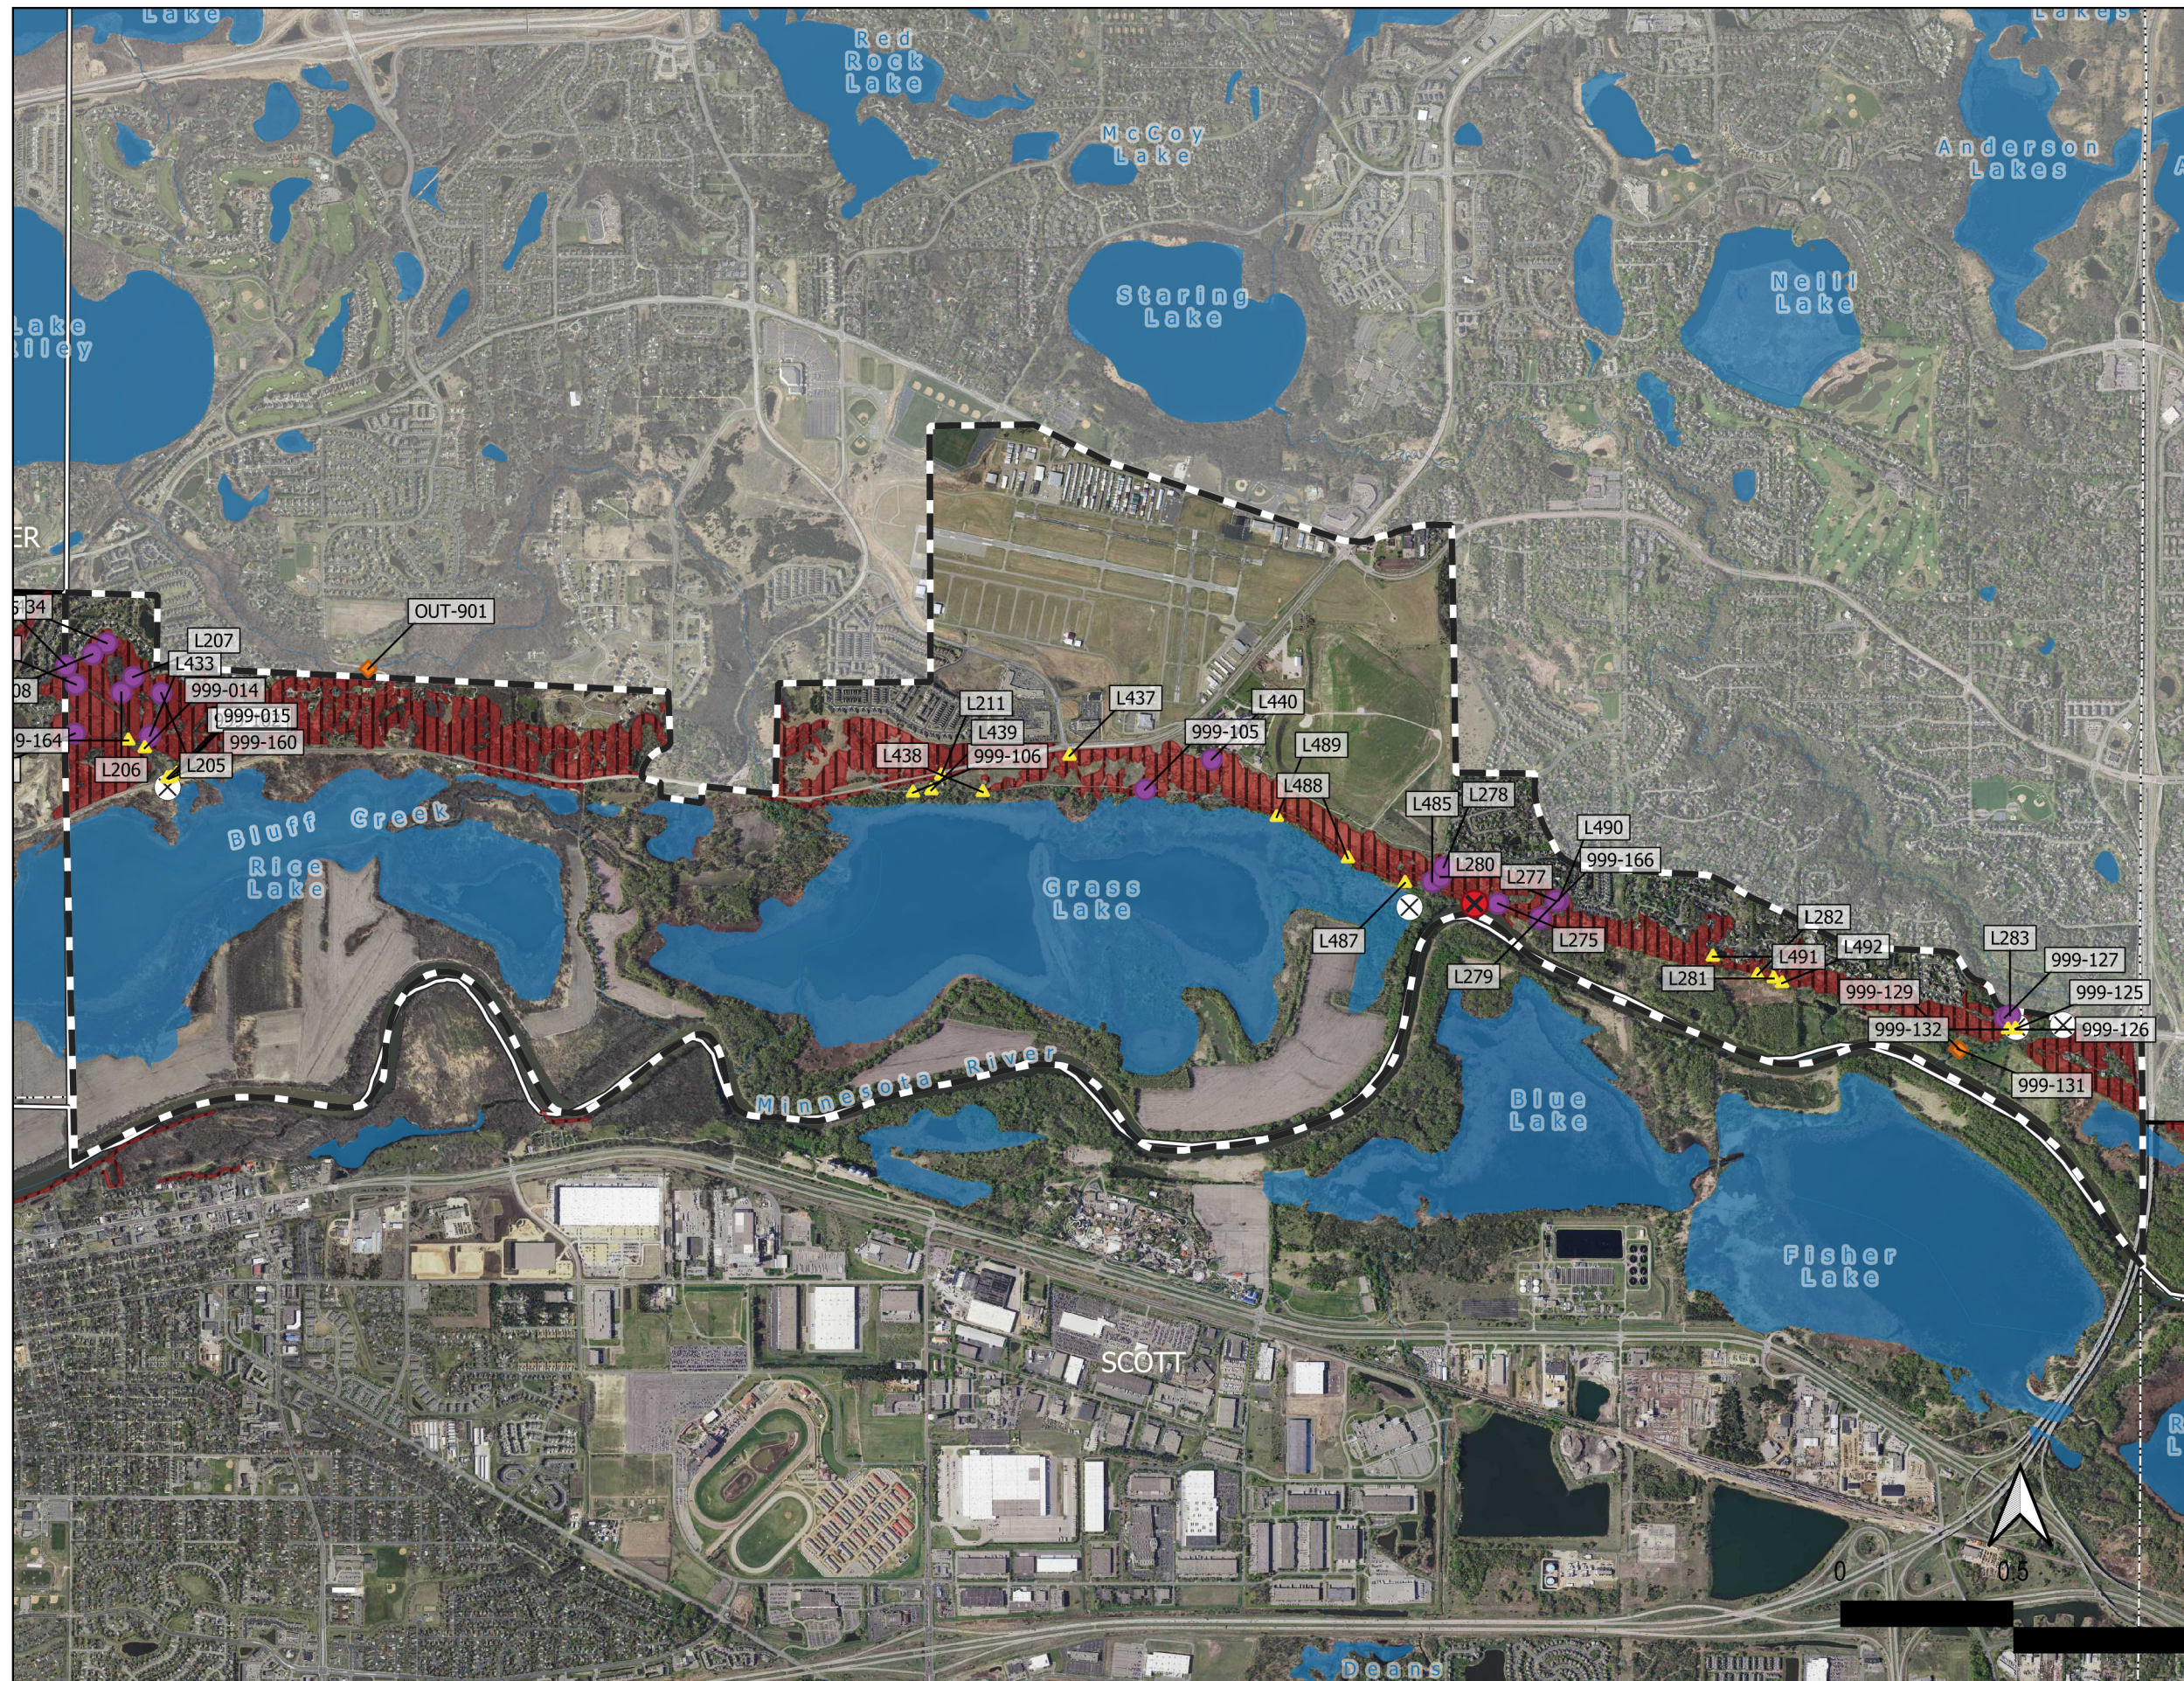
**Figure 91:
Eden Prairie 2020
Gully Locations**

During the 2020 field season, the field team collected data at 53 locations. At four locations, the field team could not locate the indicated pipe outfall or road culvert. Some features may have been removed. Two locations were determined not to be applicable to the project because they consisted of generalized erosion that could not be characterized as a true gully. One location was found to be a duplicate point and was removed in the field. The remaining 44 points were all confirmed as either a gully, pipe outfall, or both (**Figure 91**).

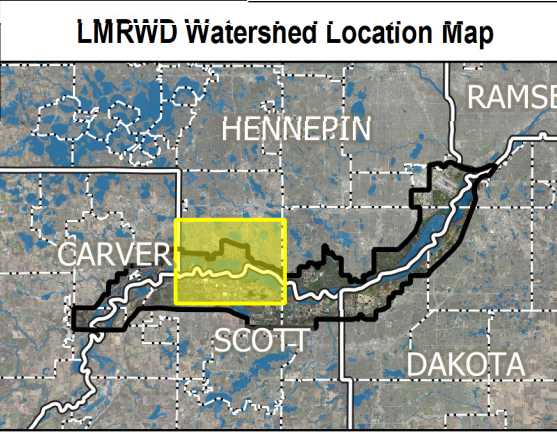
To better assess the erosion progression of an individual site, the change in erosion potential is mapped in **Figure 94**. There were six sites in Eden Prairie that changed erosion potential from the 2008 Inventory to the 2020 Inventory. Four of the sites have increased in their erosion potential, moving from moderate or low erosion potential to high erosion potential; these are discussed in more detail within their respective HPRs. Two other gullies were observed to have a reduced erosion potential: one from high to low and one from moderate to low. High priority was placed on the sites that became more severe between the 2008 and 2020 studies. The ranking of sites in less-severe categories owes largely to the limited information available from the 2008 study for ranking determinations, with the more appropriate ranking of the sites in the 2020 study attributable in part to improved data collection rather than any significant progressive change in conditions.

Three HPRs have been identified within the City of Eden Prairie. All the high-priority sites are in the steep slopes district (**Figure 94**).

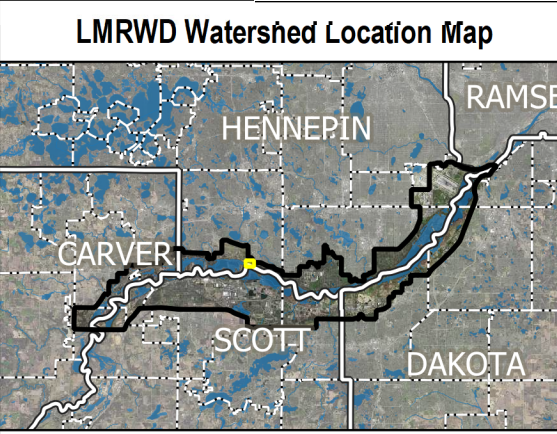
L275 was noted as having high erosion potential in the 2008 study due to the bare soil noted around the pipe in the picture taken by the field team. At the time of the 2020 site visit, the field team could not safely reach the pipe outfall to clearly assess it because of unstable slopes, which indicates the amount of erosion that occurred along the bank since 2008. A comparison of the pipe outfall in 2008 and the bank erosion noted in the 2020 field work appears below in **Figure 101**.

The other gullies in this HPR were all noted as having moderate erosion potential in 2008 based on the pictures and descriptions from the time. The 2020 field team assessed these sites as having high erosion potential because of observed active erosion and unstable banks along the head cut. However, Site L277 had a medium depth and bottom width, Site L278 had a medium length, and Site L279 had a narrow depth and medium top width. Therefore, although the erosion within each gully was severe, the smaller size of the gullies makes this region a lower priority for restoration than the gullies in HPR 14.

Factors contributing to the formation and erosion of the high-priority gullies in the region included groundwater seepage, steep slopes throughout Eden Prairie, and a dense canopy and subsequent lack of vegetation. Common problem indicators within these gullies included slumping, overhanging banks, and leaning trees. Incision was noted at sites L277 and L279. **Figure 102** below illustrates incision caused by groundwater at Site L277.
